## **Line 2 (Bloor-Danforth) Wheel Flats Update**

**Date:** July 10, 2019

**To:** TTC Board

**From:** Chief Vehicle Officer (Acting)

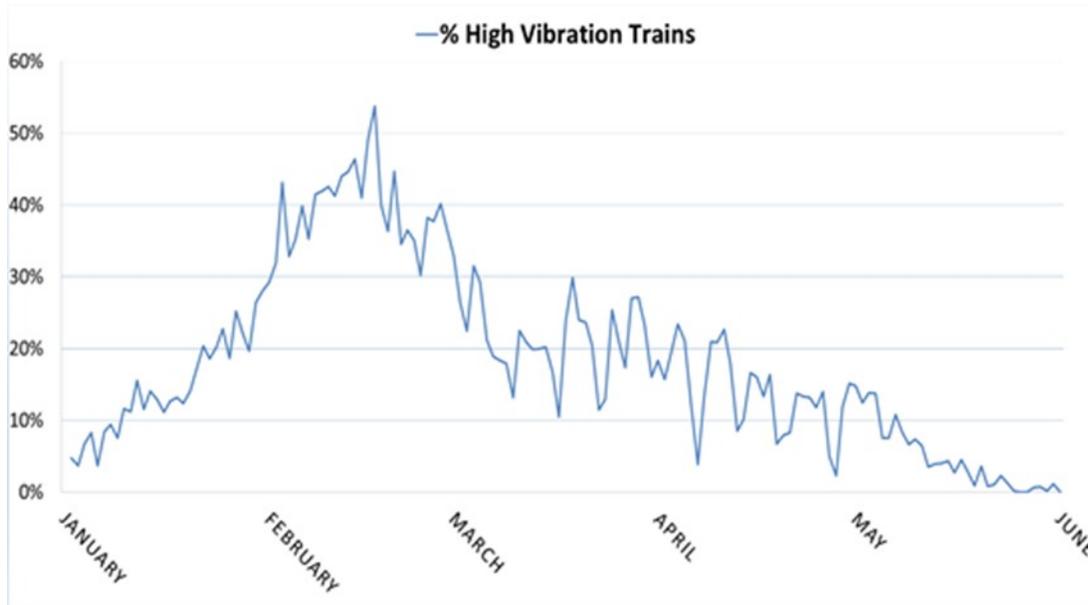
**Chart B – % Trains Exhibiting High Vibration**

The number of new wheel flats continued to remain high throughout January and February 2019. Given the large backlog of flats experienced, to ensure subway service requirements were met, trains had to be placed into service with this defect. As a result,

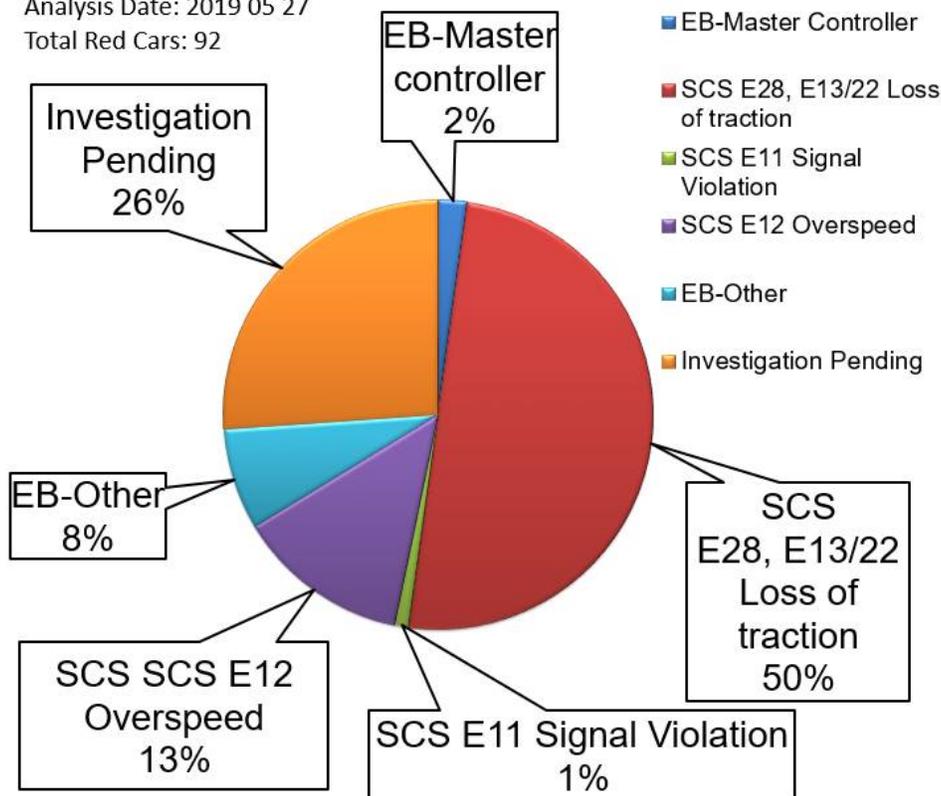
## RED FLAT CARS BY EB EVENTS, APRIL 2019

Data from the Speed Control System was also analysed. This data highlighted instances of EB application and potential reasons for the application. The graph below is an example of the data analysed weekly. From this data, the investigation team would determine tests and investigations to perform in attempts to reduce the number of wheel flats generated. For example, operator information campaigns were implemented when it was identified that the number of EB applications due to over speed and signal violations increased. In addition, speed restriction zones were implemented in the open cut sections during inclement weather to minimize wheel slip.

Analysis Date: 2019 05 27  
Total Red Cars: 92
