# **Reducing Subway Noise and Vibrations**

**March-April 2019**

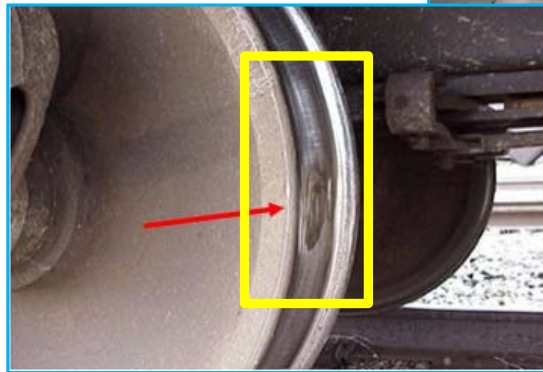
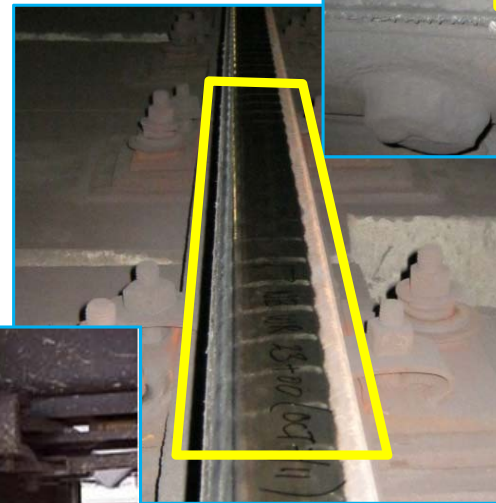
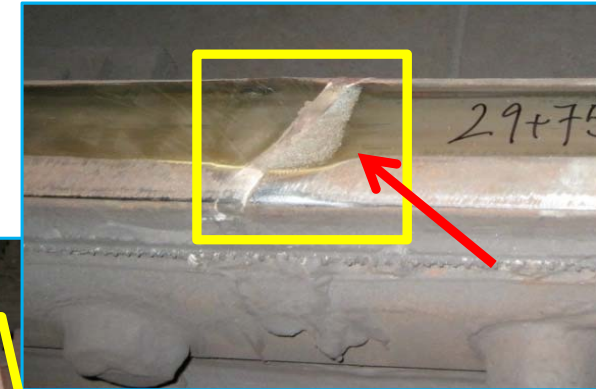
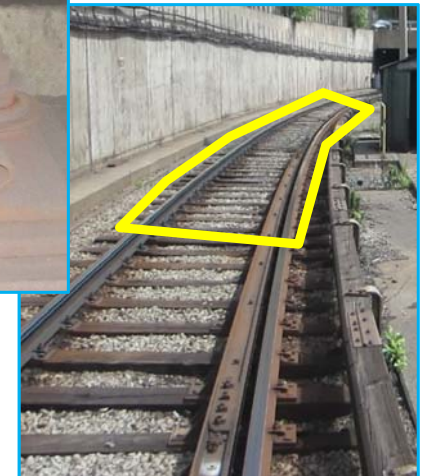
- Rail joints/welds
- Rail roughness (corrugation)
- Track curves (wheel/rail interface)

- Wheel uneven wear
- Wheel flat spots

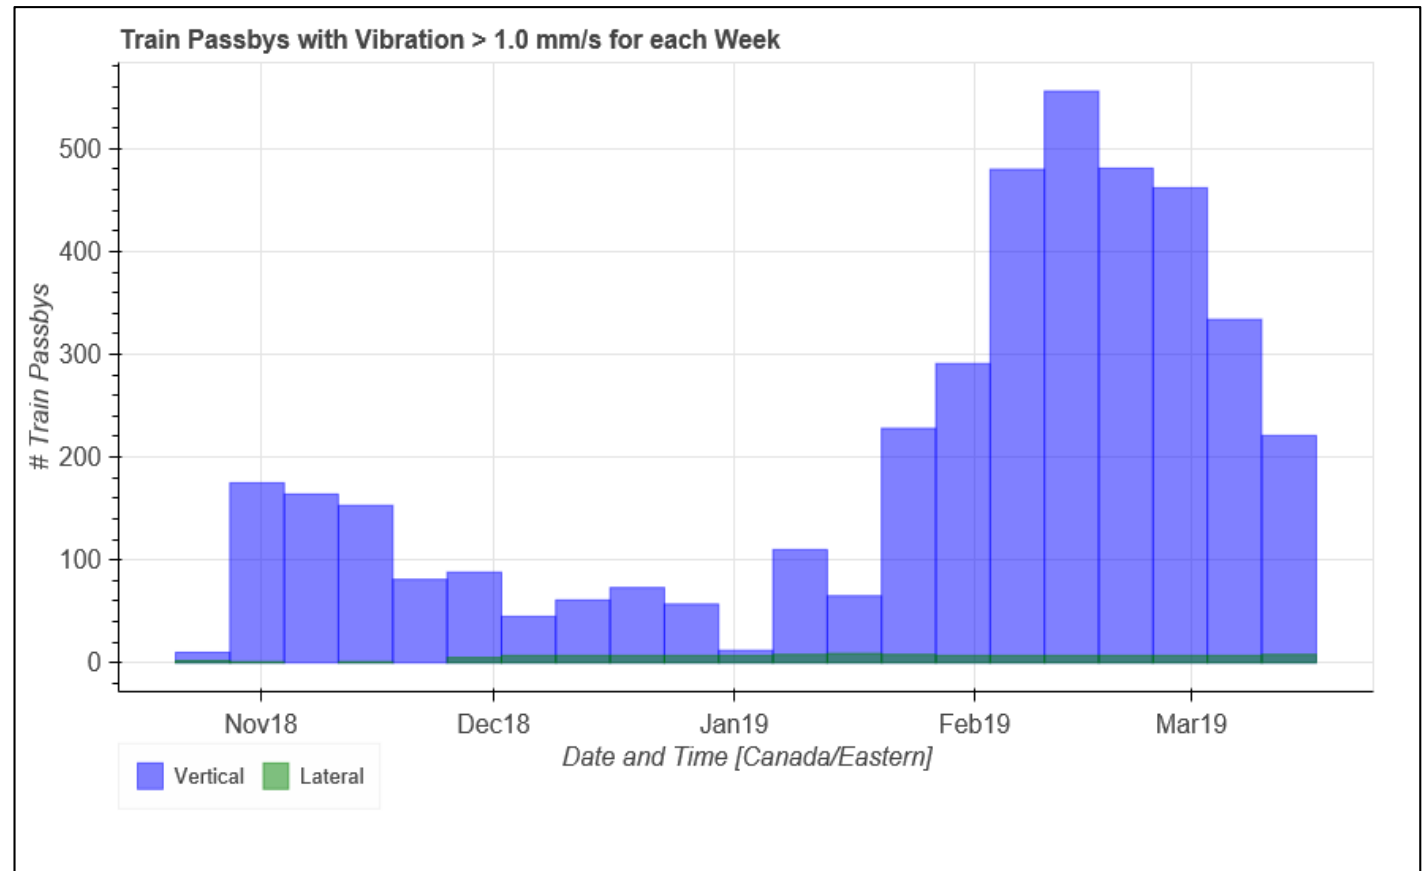
## Vibration Monitoring Equipment

- Installed on Line 2 in 2019
- Measures the combined effect of wheel and localized rail conditions on the structure.

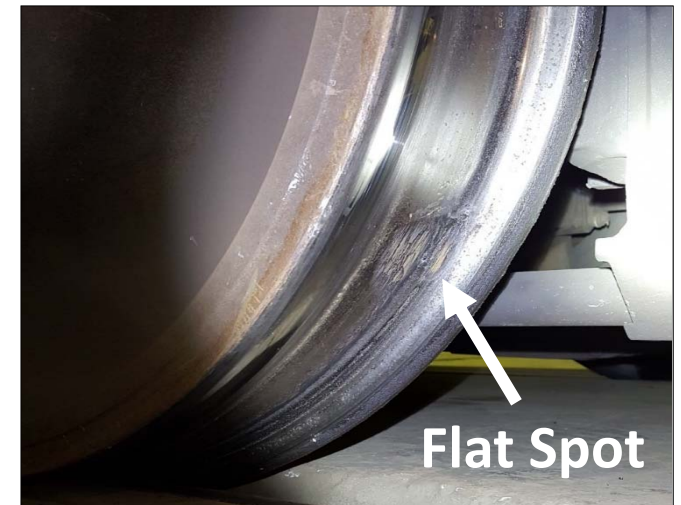
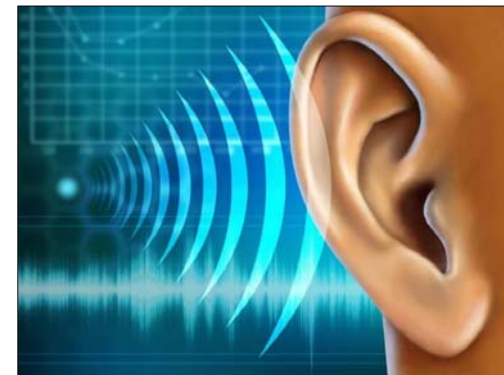
- Line 2 – Sudden increases in flats have been the dominant factor contributing to N&V since October 2018.
- A subway “flat” is an indent on the running surface of the wheel.
- Flats range in size / varying degrees.
- A patterned thumping sound as wheels rotate along rail.

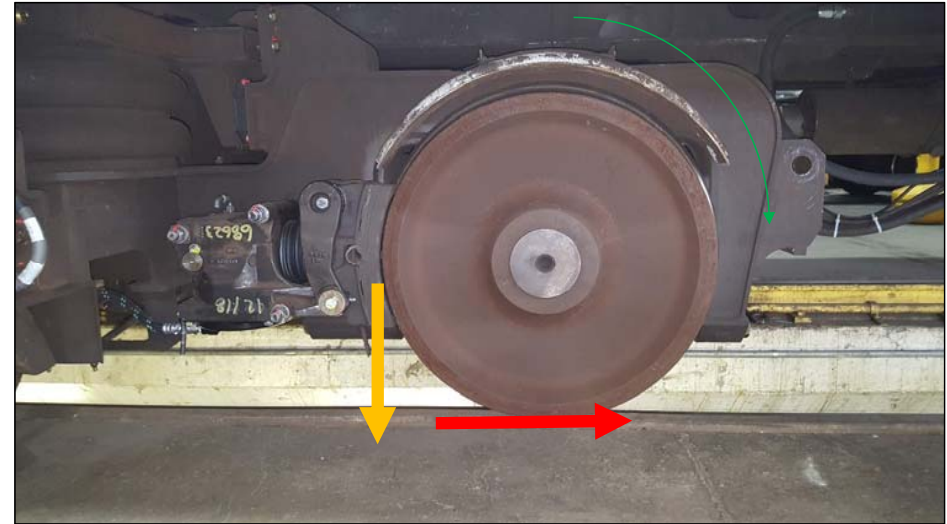
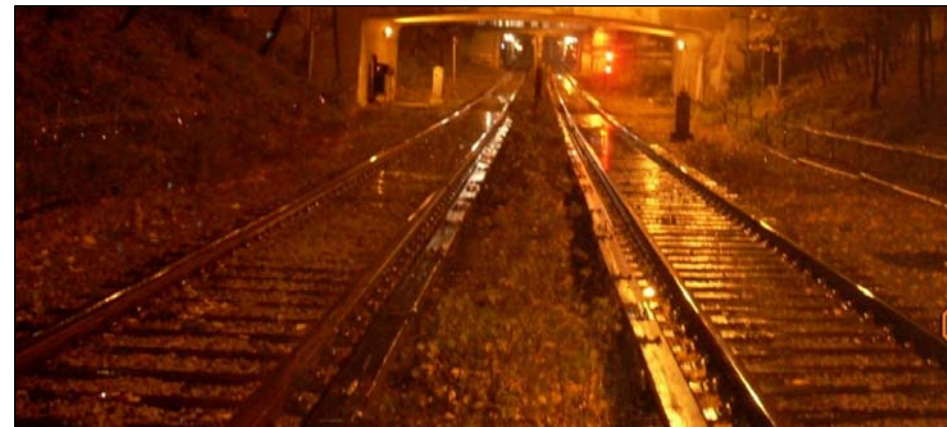
- Rail conditions combined with Emergency Braking (EB) can cause wheels to lose adhesion (slip), stop rotating and slide along the track.
- Wet rail, leaves, snow, and over-lubrication can cause areas of low traction.
- A “flat” is an indent on the running surface of the wheel.

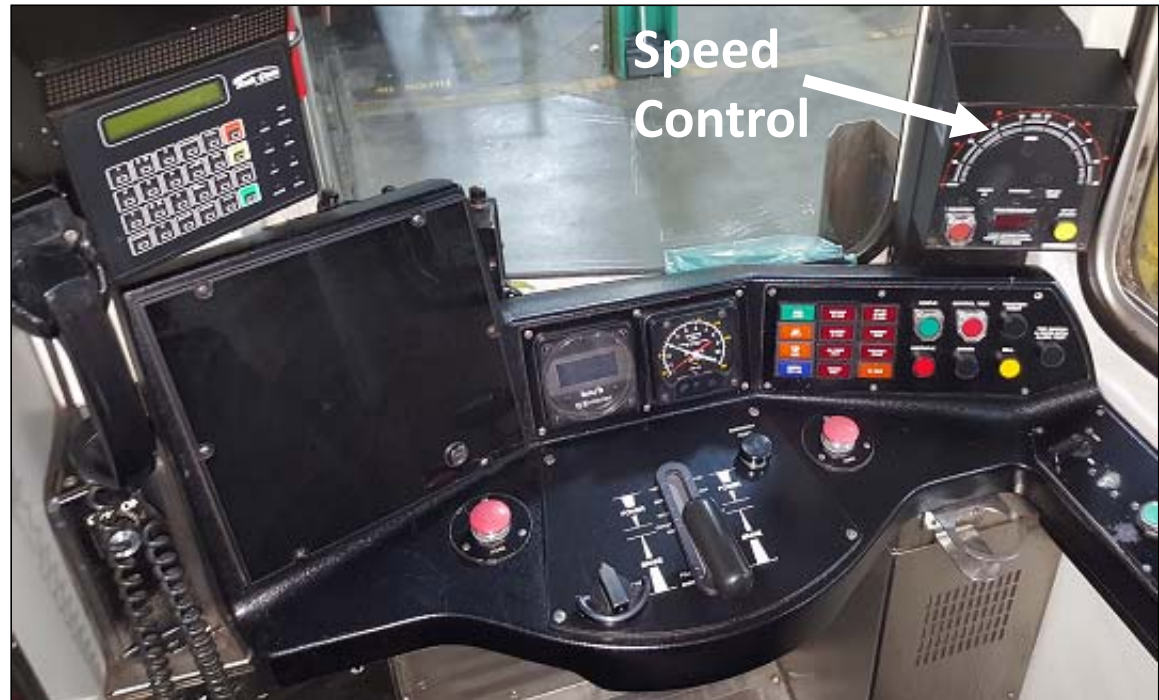
- Subway Operators may suddenly need to stop.
- The on-board “Speed Control” System will engage, as a safety override, and stop the train.

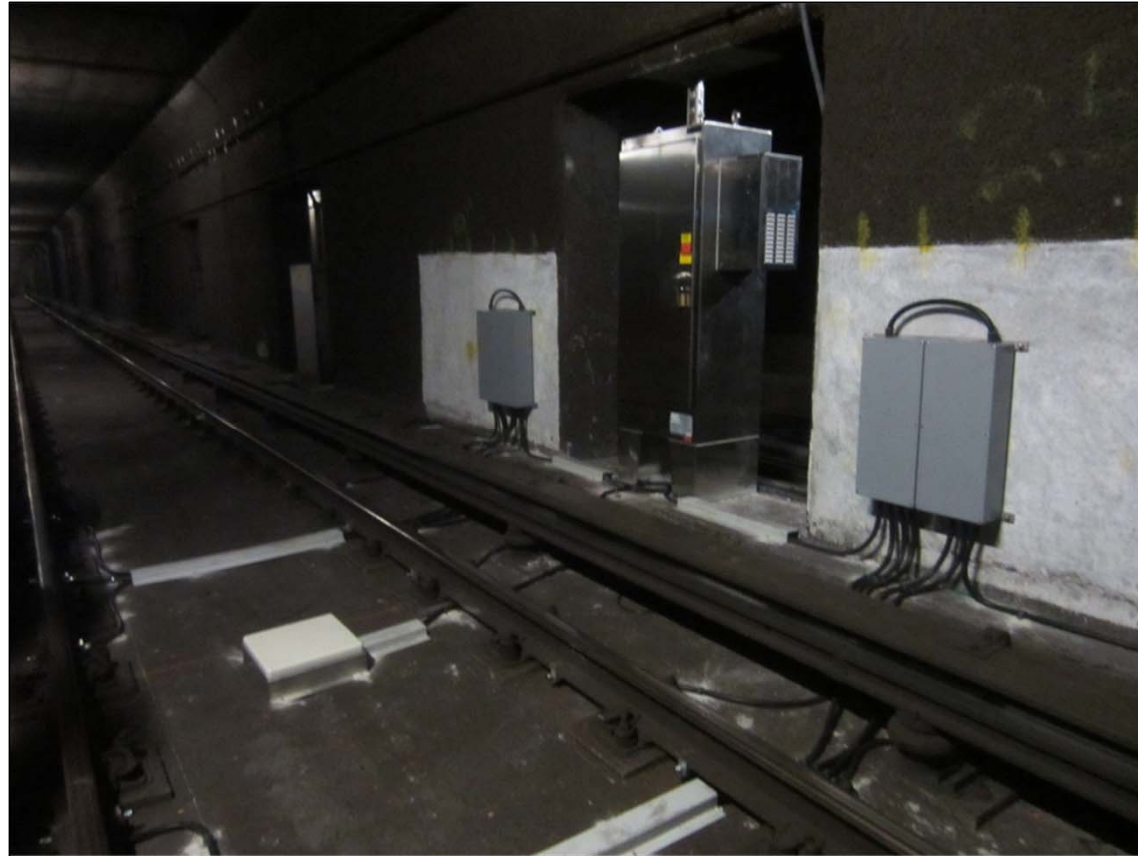
## Wheel Flat Detection System - Line 2

- Thorough Visual Inspections - every 35 days
- Subway Operator reports
- Wheel Flat Detector - westbound at Warden Station - 24/7 real time

- Installed on Line 2 in 2012
- Installed on Line 1 in 2015
- Monitors wheel condition in real time (24/7)
- Detects wheel flats and can determine severity of wheel condition
- Measures and reports impact forces
- Identifies specific car axle and wheel to be repaired

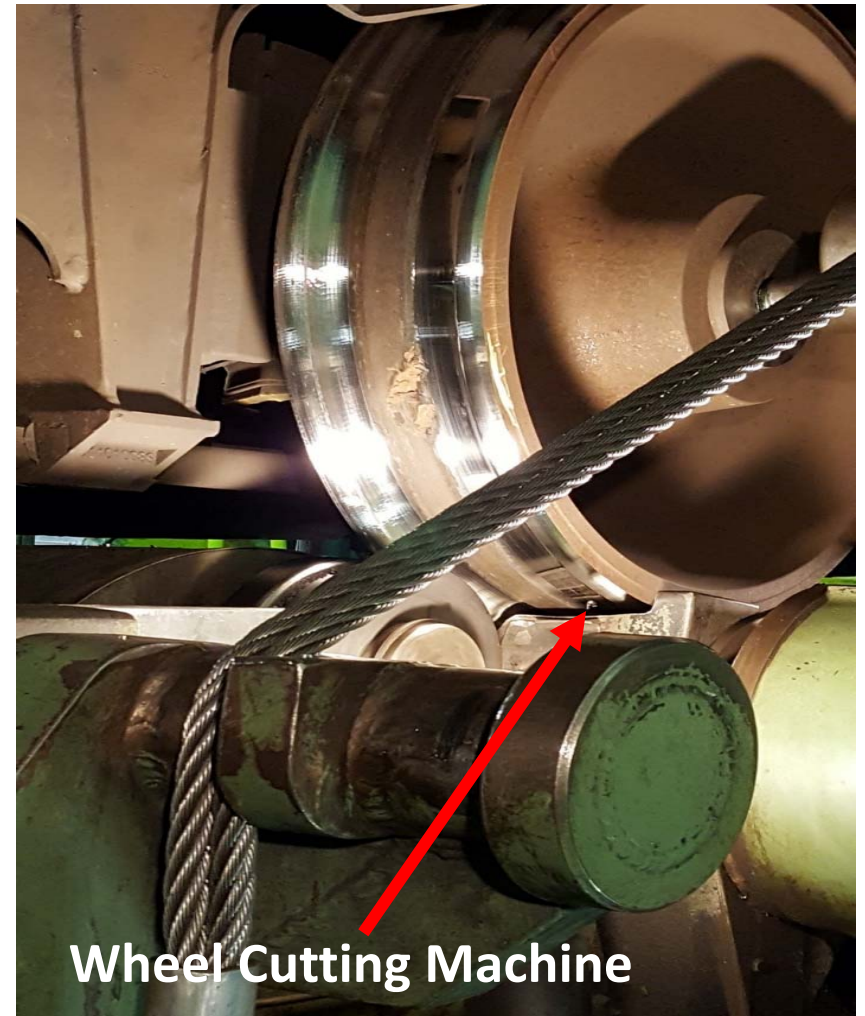
- Wheels are 'machined true' to remove flats and be re-profiled.
- A maximum of 6 axles (12 wheels) can be machined during an 8 hour shift.
- Wheel Turning Machines at both Greenwood and Wilson yards have been used at capacity to address current Line 2 wheel flat issue.

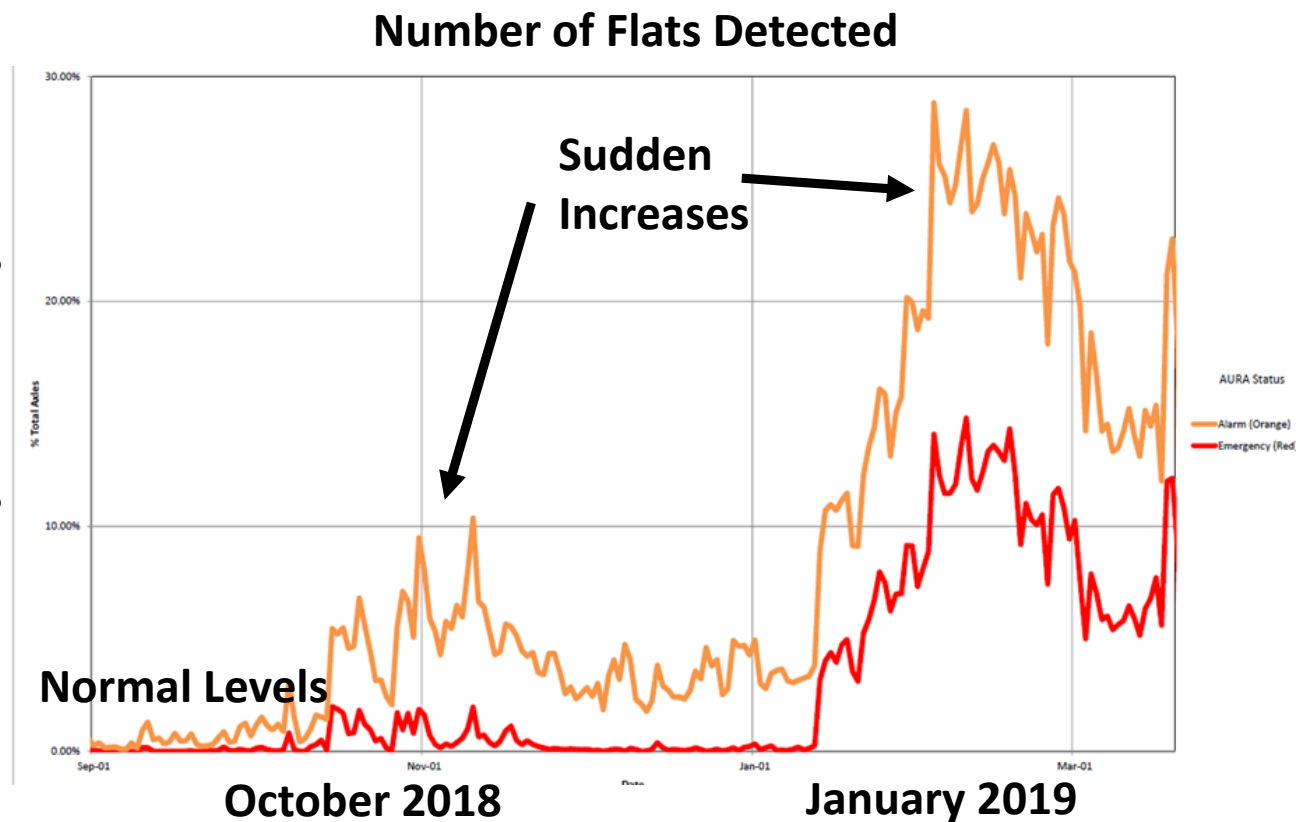
## Seasonal Flat Occurrences vs Winter 2018/19

- Wheel flats are a regular annually occurrence in the Fall.
- Abnormal sudden increases in “wheel flats” in October 2018 and January 2019.
- Unable to “machine” wheels faster than flats developed.
- Trains in service with wheel flats to meet service requirements.
